Technical Preservation Services
Preservation Assistance Division
National Park Service
U.S. Department of the Interior
Washington, D.C.

Interpreting the Secretary of the Interior's Standards for Rehabilitation

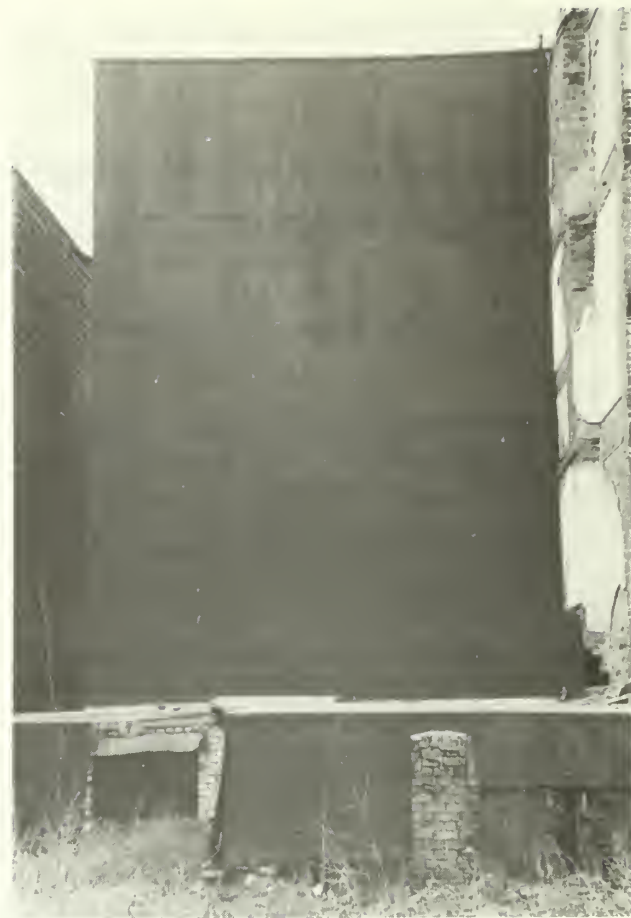
2. Limited demolition at the rear of the building had already occurred and protective boards had been applied.

Application: A deteriorated, three-story, three-bay wide brick structure built in 1843 was certified in the Part 1 application as contributing to the significance of the registered historic district--a 13 block area of 19th century Federal and Greek Revival structures (see illus. 1,2,3,4).

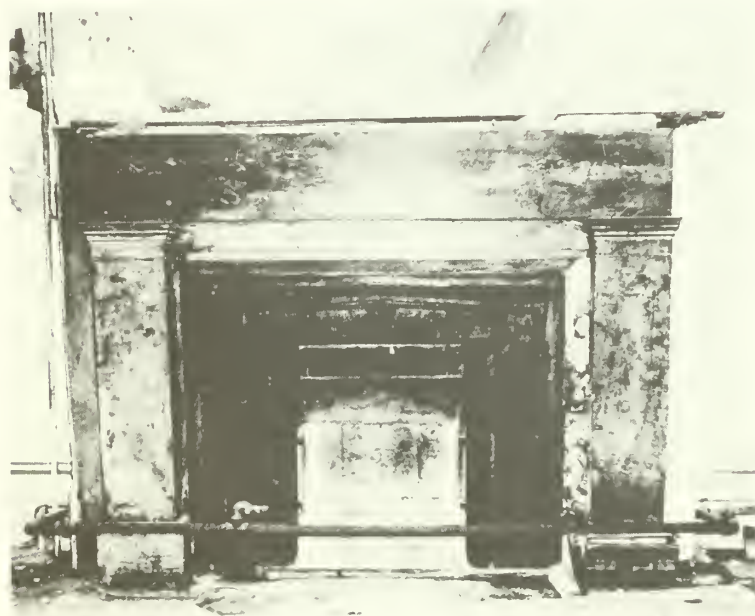
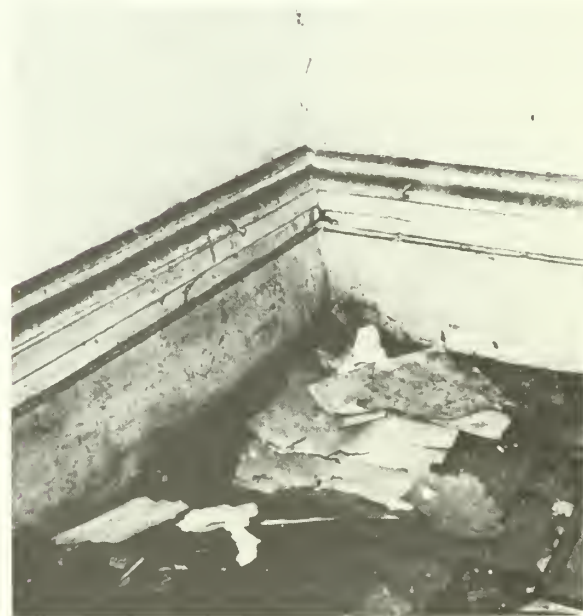
3, 4. The interior, with intact trim and mantels helped define the character of this simple, mid-19th century structure.

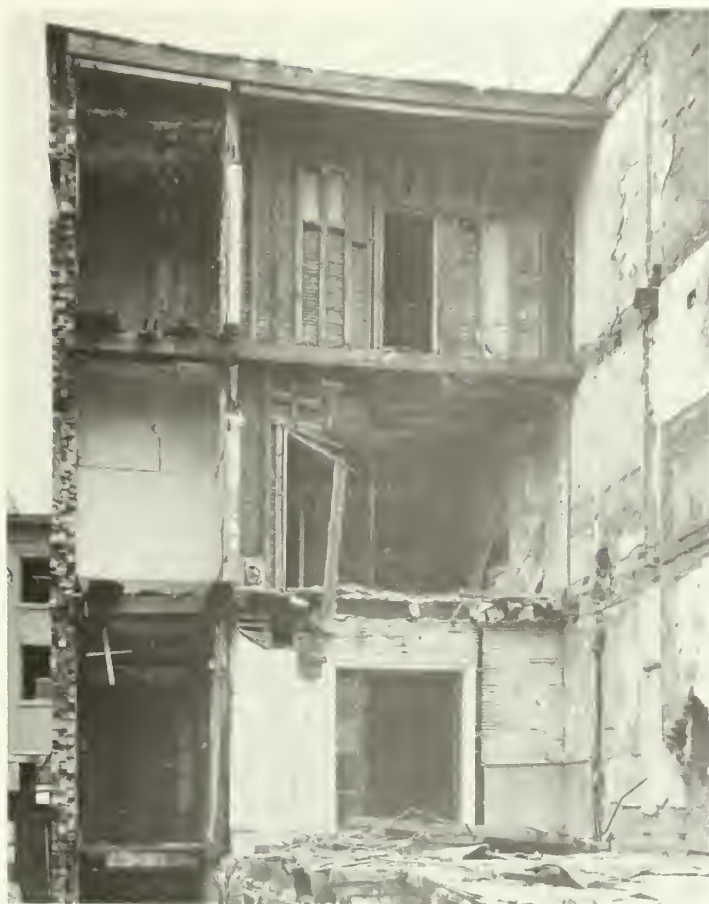
5. Crucial to the decertification of the structure were additional photographs documenting the condition of the rear of the building prior to rehabilitation. After removal of the boards, this new information showed that barely 1/3 of the building remained.

The new photographic documentation that you submitted shows that barely one-third of the building was standing at the time rehabilitation work commenced. As a result of the building's extremely deteriorated condition, significant architectural features are too deteriorated to be preserved on the remaining portion of the building. In addition, nearly all interior finishes are to be replaced and rebuilt using new materials. As a result of the new information, we have determined that No. 2 of the "Standards for Evaluating Significance Within Registered Historic Districts" has been met (e.g., the structure does not contribute to the significance of the district) and, therefore, the building cannot qualify as a "certified historic structure." This decision supersedes the earlier decision...Since the building does not qualify as a "certified historic structure," in accordance with Department of Interior regulations, the project is not eligible for certification of rehabilitation.

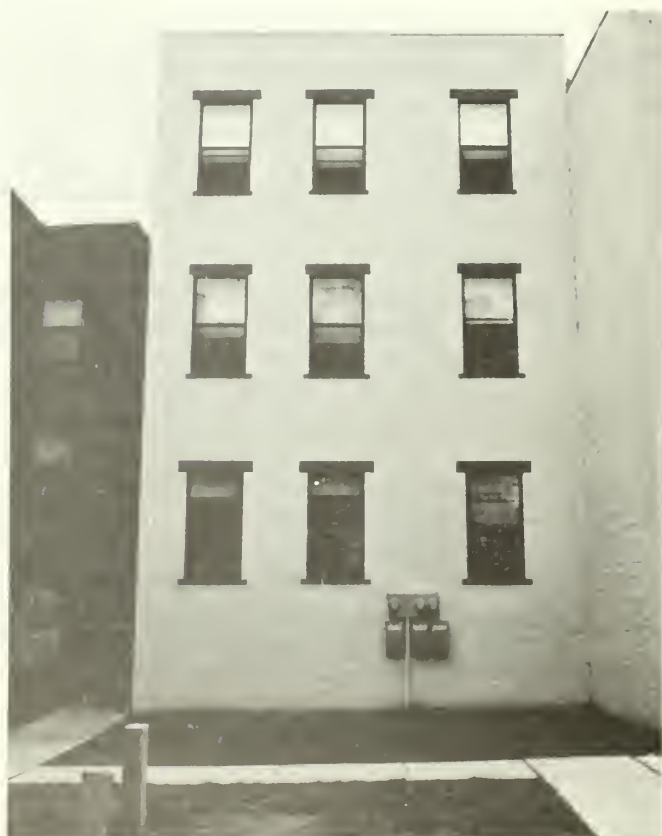
7. The rear of the building and major portions of the interior required extensive replacement of historic material with new material.

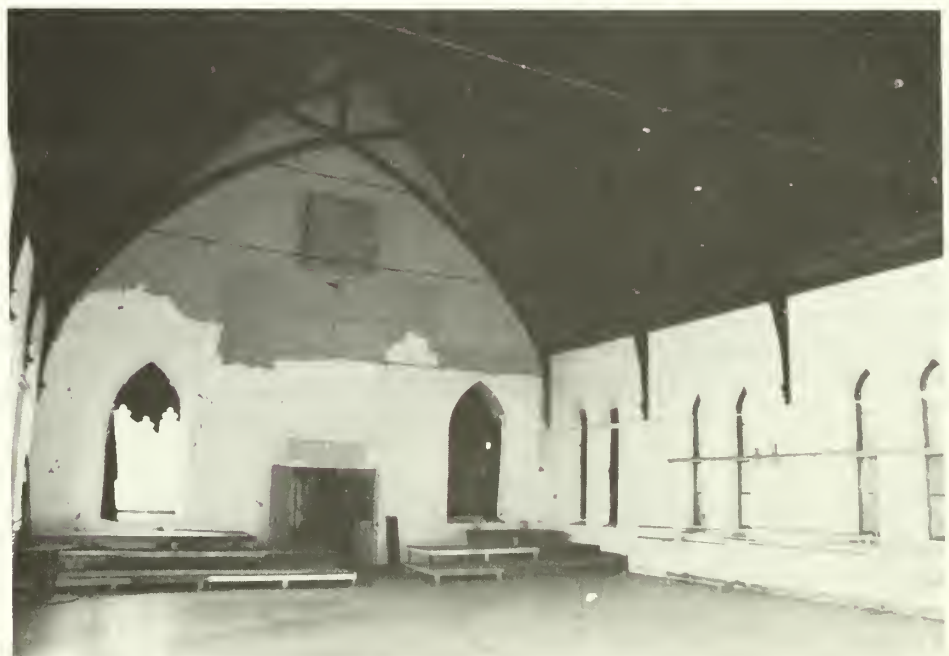
1 and 2. Interior of the church at the time rehabilitation planning commenced. Remaining features include regularly spaced windows, roof structure and exposed scissor trusses, original floor to ceiling height. Only the church furnishings had been removed.

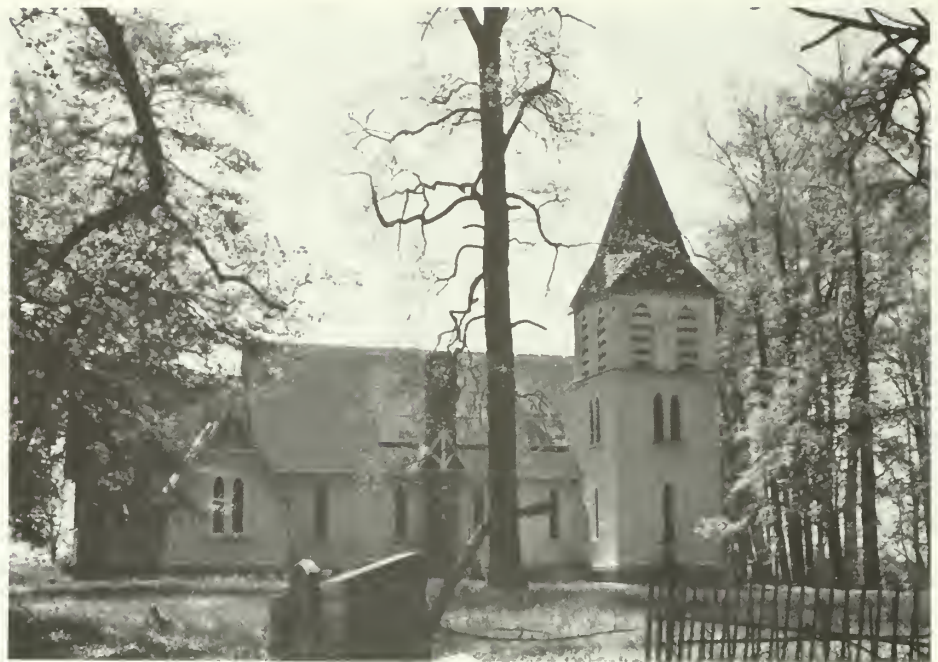
5. North elevation showing new skylights inserted in nave roof after rehabilitation.

The owner appealed the denial, arguing that the skylights were not highly visible on the exterior to passers-by, as that elevation of the church faces onto an abandoned cemetery, not a public-right-of-way. Furthermore, their installation did not result in extensive loss of historic fabric because materials removed were used to patch damaged areas of the roof. The owner also stated that the mezzanine and stairway inserted in the chancel and the bathroom and storage sheds in the nave were sensitively designed and compatible with the historic character of the church (see illus. 5-6).

The sky lights were introduced directly behind the bell tower in the north slope of the roof which faces away from the principal approach to the building; they are not obtrusive from the exterior, nor are they so numerous as to adversely affect the character of the interior. The mezzanine, circular stair and sheds were introduced to the interior with minimal damage to the historic fabric. While the chancel arch was partially enclosed in inserting the mezzanine, the windows in the east wall remain visible through the glass panels and open circular stair. The pendant sheds constructed in the nave similarly respect the axial lines and tunnel-like view of the church interior from the west end towards the east. In fact the slope of the shed roofs focuses the lines of sight toward the chancel and the windows beyond (see illus. 6). The changes made to the interior of this building are consistent with the historic character of this historic structure, and I find them in conformance with the Secretary of the Interior's "Standards for Rehabilitation."

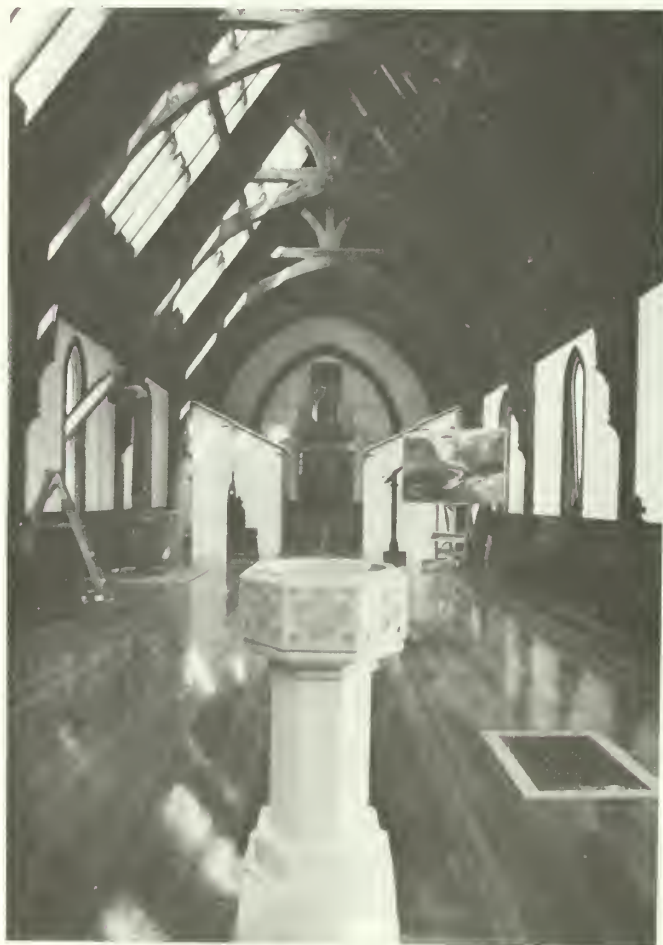
6. View of nave looking east. Note the 2 new sheds in front of and on either side of spiral stairs in center of sanctuary arch leading to mezzanine.

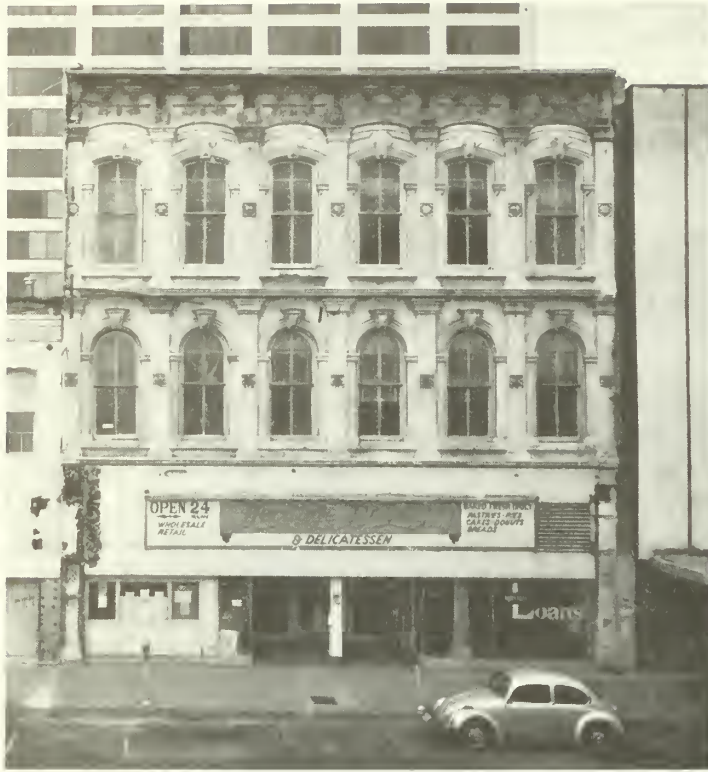
1. At the outset of rehabilitation, an 1866 limestone building was missing its ornamental cornice; and the ground level storefront had been extensively altered.

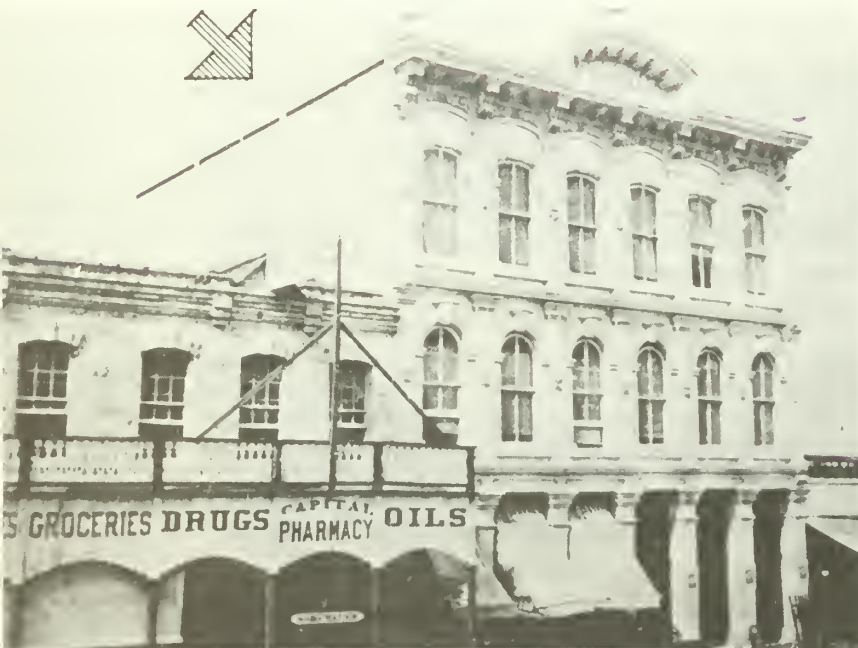
2. Based on the availability of this and other photographic documentation, the owners were able to accurately restore both the cornice and the storefront to their historic configuration.

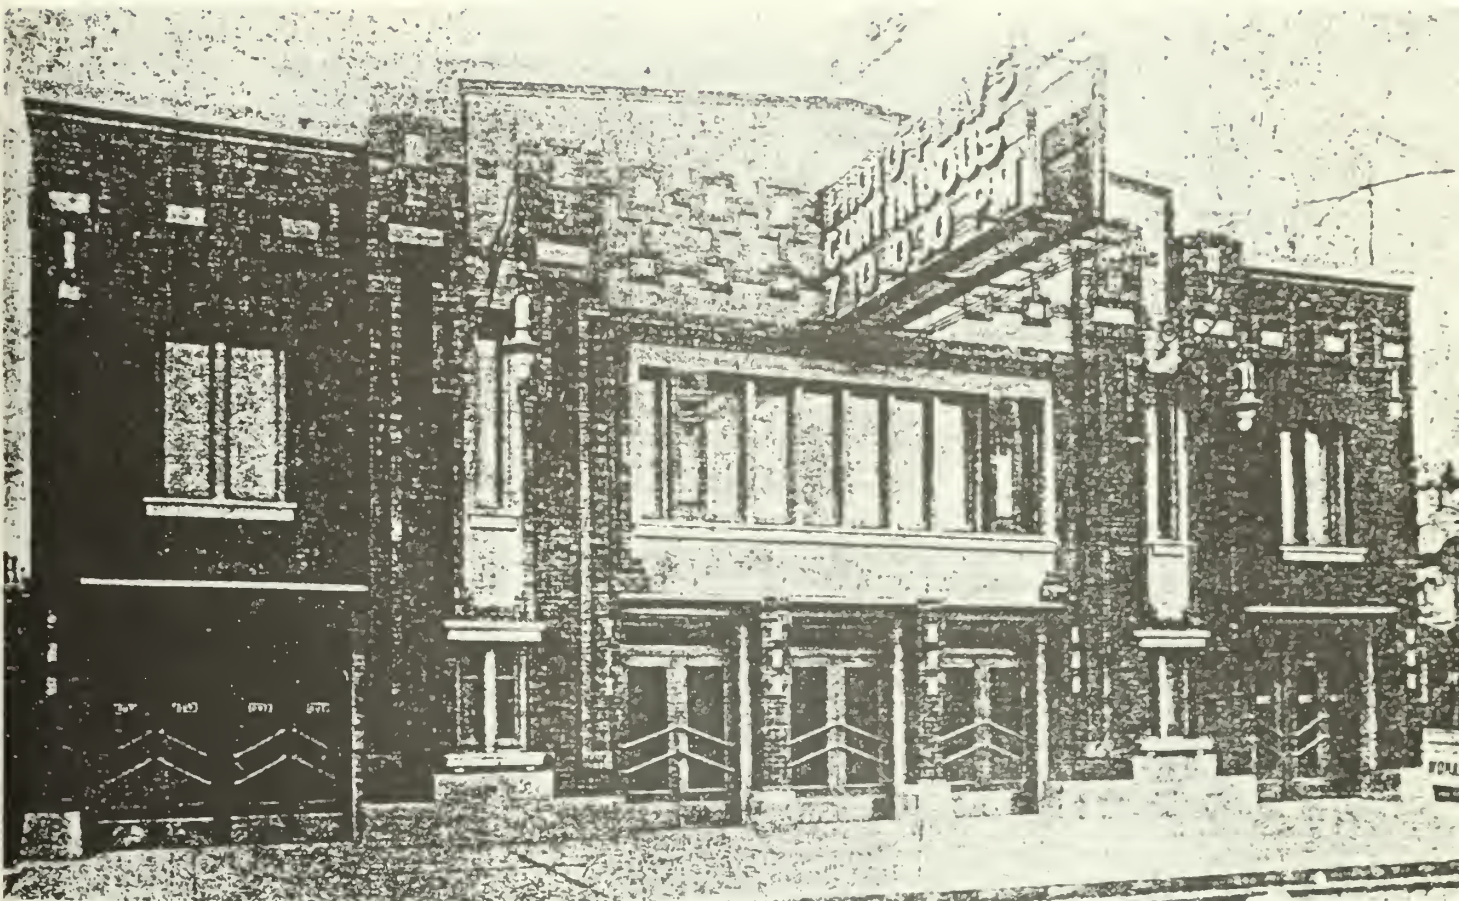
4. Historic photograph of the theatre's facade as it appeared in 1913. Note the glazed wooden double doors, repetitive features that, together with the distinctive rectangular openings themselves and the patterned brickwork, define the architectural character of the building.

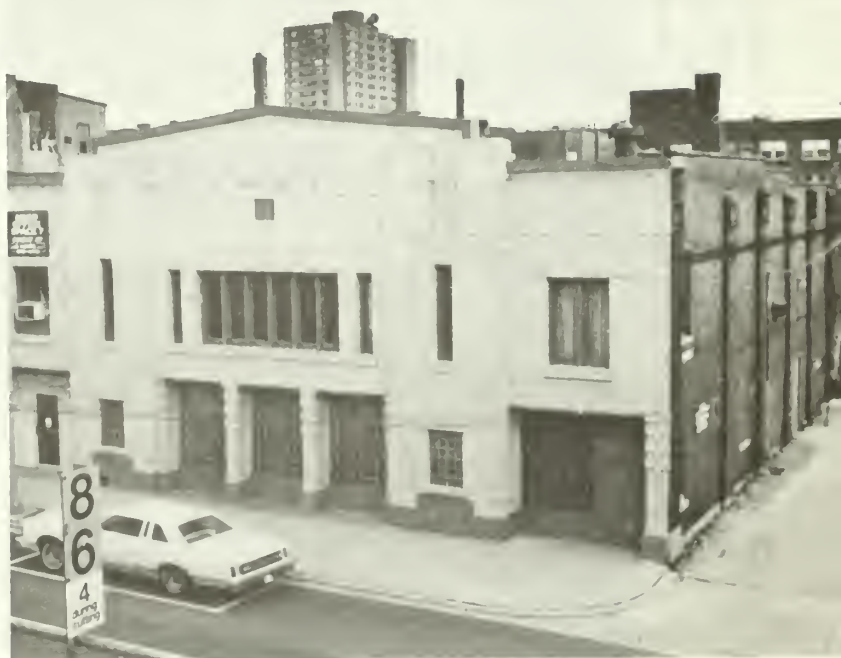
5. Theatre building as it appeared at the commencement of rehabilitation. The wooden doors had been removed in an earlier "renovation" and the openings filled-in with glass block. In addition, the masonry was painted a uniform gray. The stone sills cover a 22-inch-thick concrete floor inside.

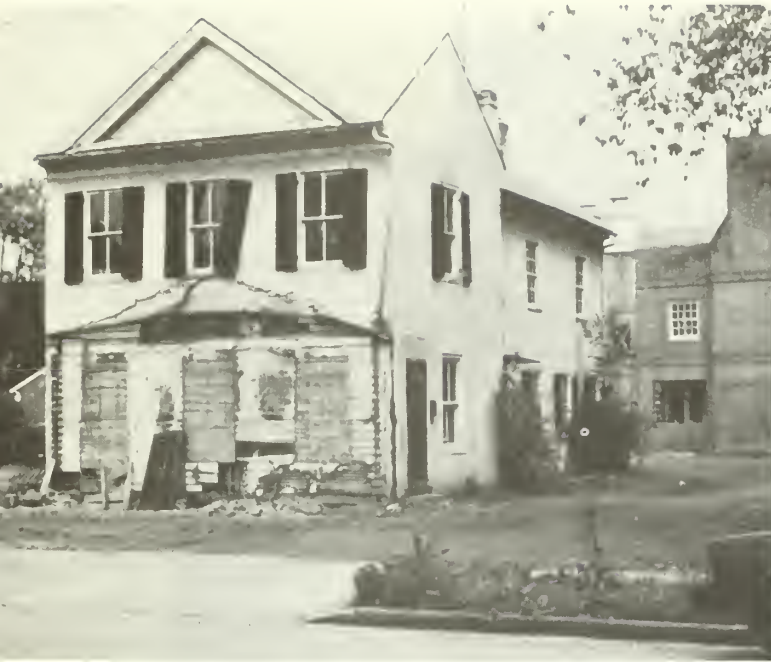
1. Front and side elevations of a ca. 1865-1870 wood frame building prior to rehabilitation. Stucco had been applied over the exterior wood at a later date and had caused rotting and termite infestation of historic wood. The building was certified as meeting Part 1 integrity requirements in its deteriorated and damaged condition.

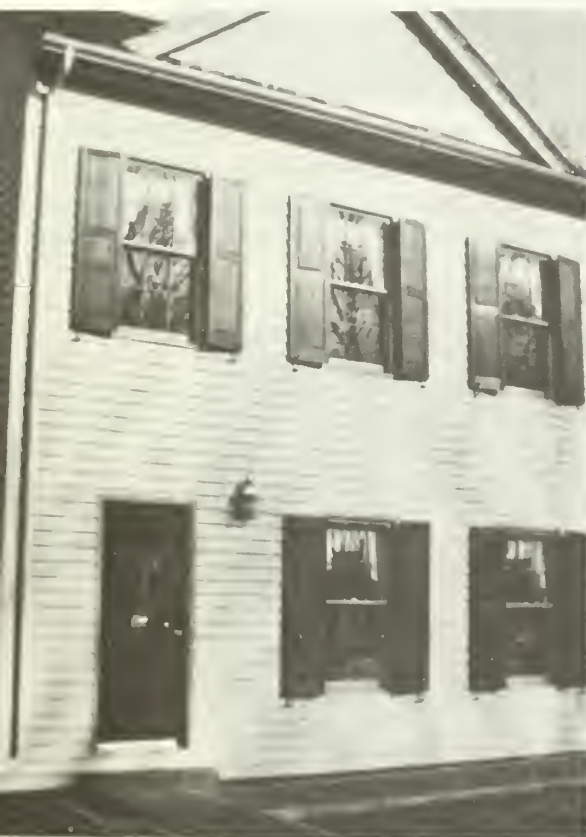
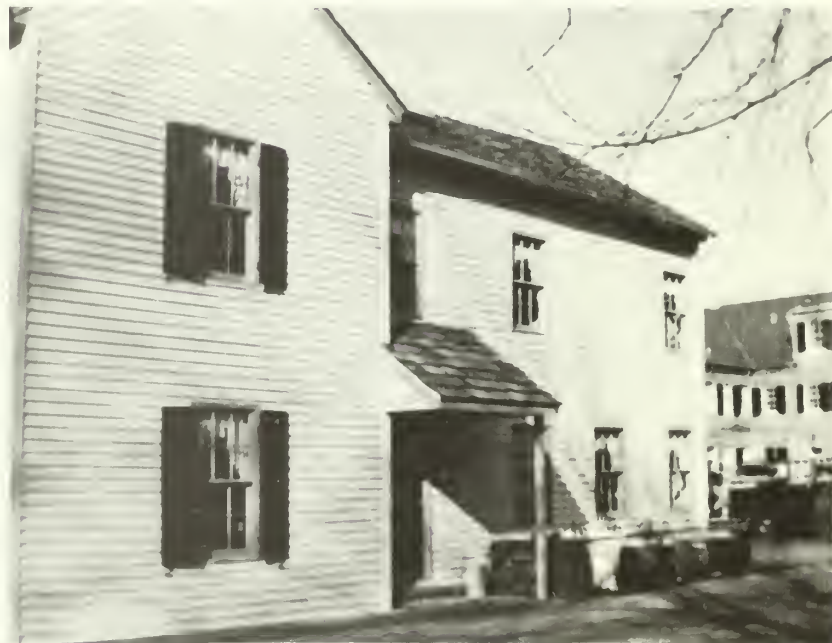
2, 3. The same building shown after rehabilitation is essentially new construction. Rather than targeted replacement of deteriorated materials, the owner replaced all of the siding, roofing, windows, sills, shutters, and trim. Some of the replacement features, such as the use of thick, cedar shakes on the roof and side porch were considered inappropriate. The owner was denied Part 2 certification on appeal. As a result of material loss during rehabilitation and the earlier loss of interior features and spaces, the Part 1 certification was also withdrawn because the building could no longer meet integrity requirements.

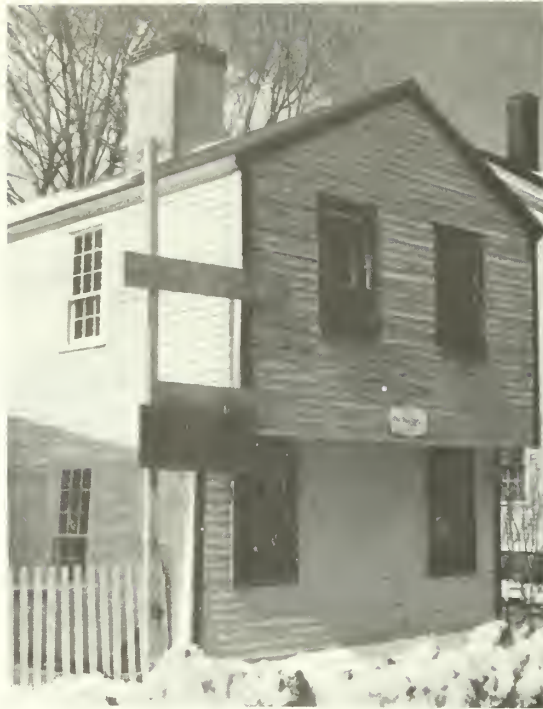
4. A ca. 1769 building was certified in the Part 1 application in its existing condition, which involved extensively deteriorated exterior wood clapboarding, sheathing and window sash. On the interior, some original framing members were intact, while others were repaired or replaced.

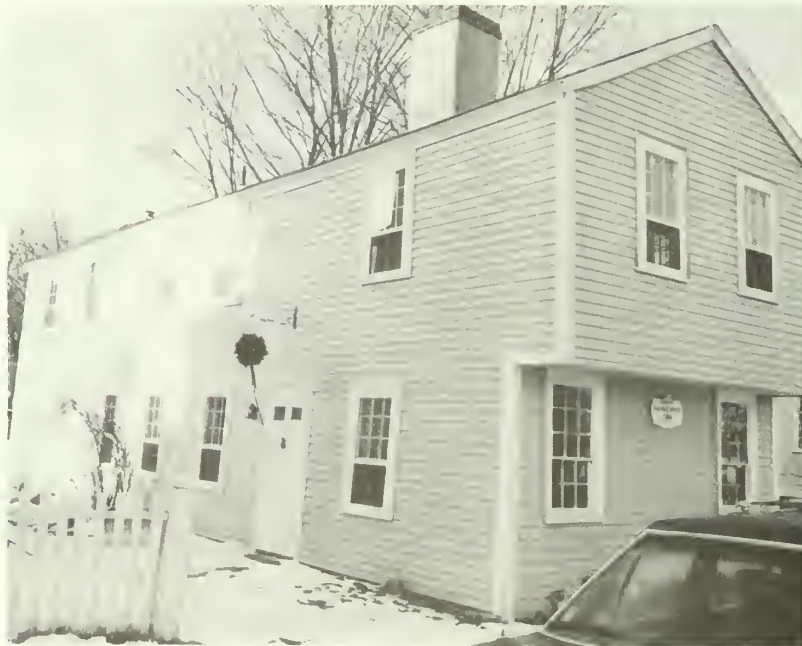
5. Completed exterior work shows the extent of replacement of deteriorated exterior wood materials and features. All siding and sheathing was replaced with new wood. Window sash and frames are also new. The applicant documented areas that needed to be replaced because of extensive deterioration as well as those portions, such as the cornice molding, that could be retained and preserved.

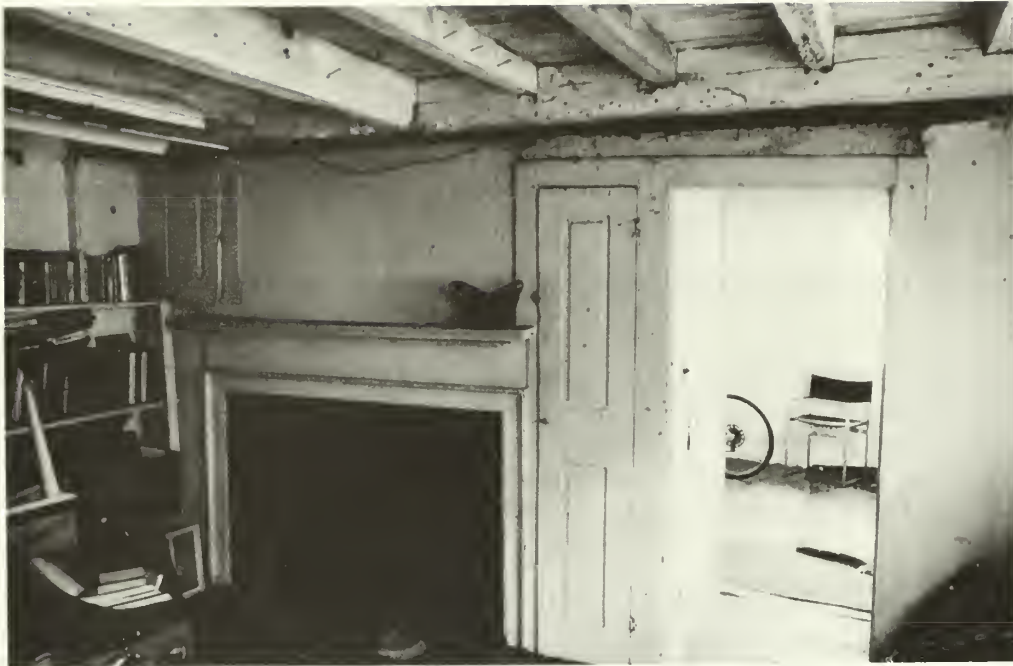
6. An early pegged-braced structural system, fireplace with bee-hive oven, and cupboards are shown. If the extant, significant interior had not been factored into the evaluation to offset extensive loss of exterior materials, overall preservation requirements for Part 2 would not have been satisfied.

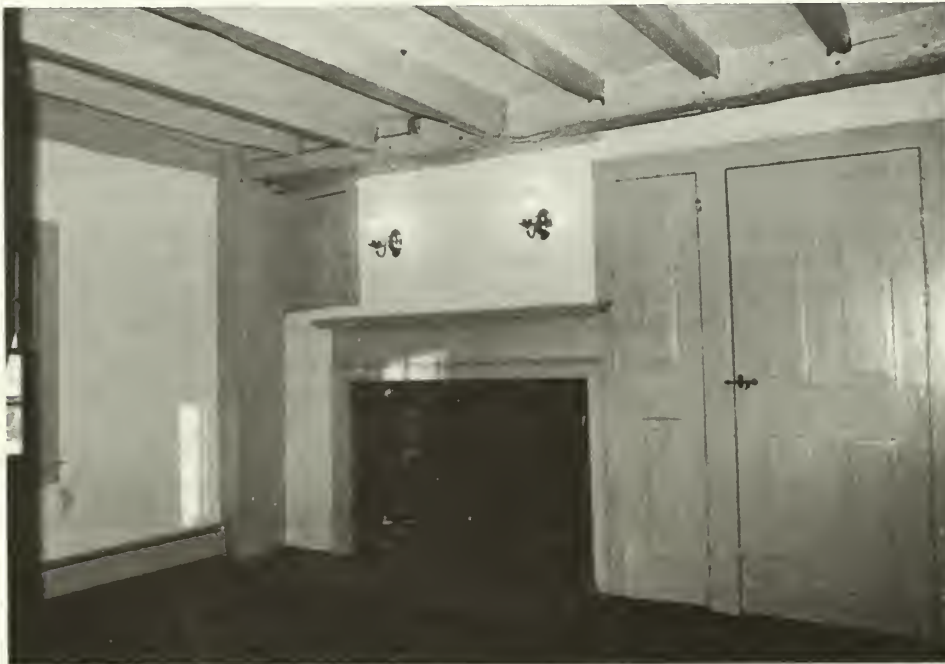
7. The same room shown above after completion of the work. On appeal, it was concluded that the building's highly significant interior, including materials, features, spaces, and an early structural system had been identified prior to rehabilitation, then carefully retained and preserved.

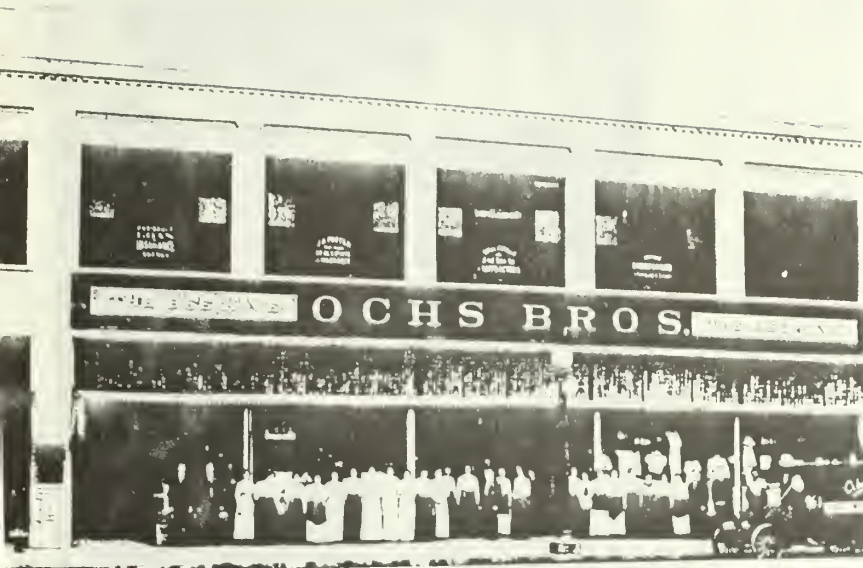
1. Early 1900s photograph of the Ochs Building shows the storefront in its historic design prior to a series of renovations, the last of which totally obscured the facade.

Application: Part 1 certification was requested for a two-story masonry building in a historic district. A photograph of the 1908 department store (see illus. 1) was submitted together with photographs of the existing appearance. In its current condition, however, it did not convey historic, architectural, or cultural

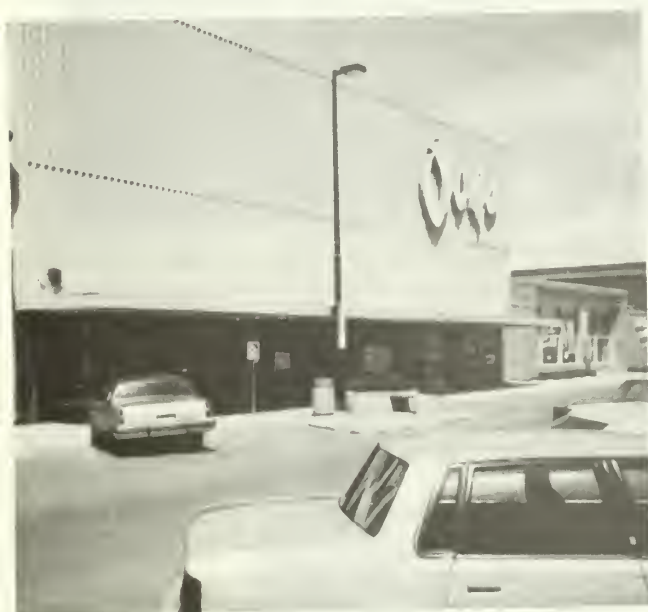
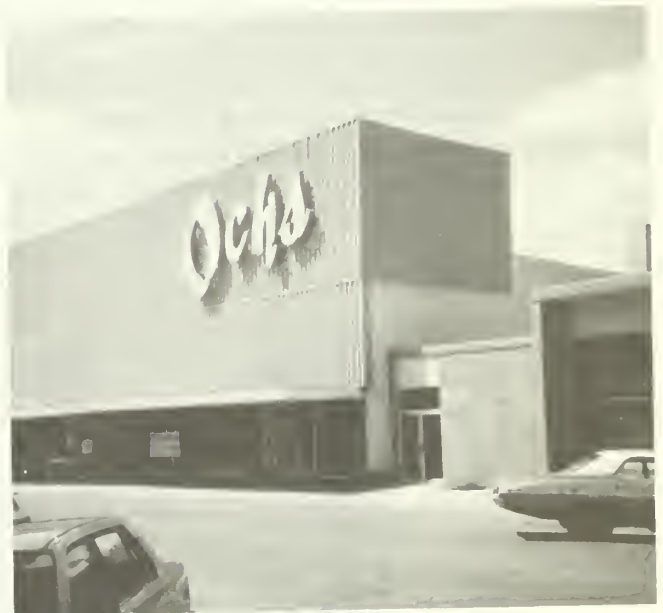
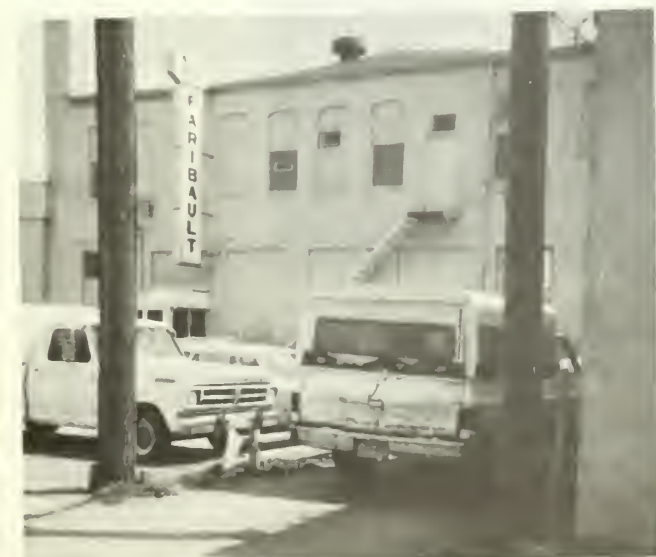
2, 3, 4. The department store shown as submitted for Part 1 evaluation, with a false front obscuring the primary elevation and enamelized metal squares covering the secondary elevation. A photograph of the rear elevation showed a portion of the building's historic material that had not been obscured. This elevation, however, was not of any particular architectural or historic significance.

Consequently, the owner was notified by the Region that at least a portion of the false front would need to be removed in order to evaluate the historic facade to see if it possessed sufficient integrity for Part 1 certification. In response, the owner informed the Region that the scope of rehabilitation would be limited to interior work, and the building's exterior would remain "as is," in its covered condition. As a result, the building was not issued "certified historic structure" status; however, if ownership were to change, a new owner could reapply for Part 1 certification of significance.

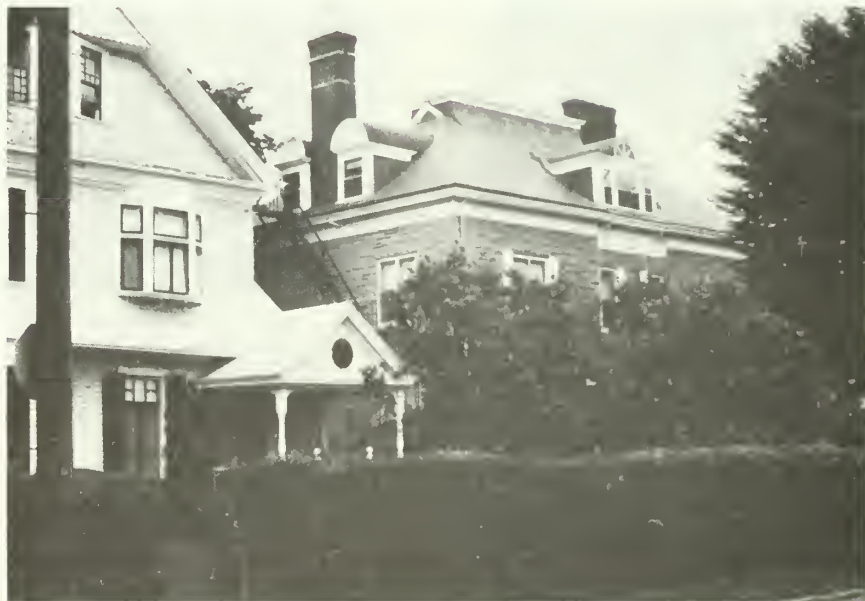
6. The building is shown here on the right in relationship to another building in the district. Although the historic wood sheathing has been obscured with formstone that is heavy and gray in appearance, the surviving physical characteristics of the rest of the building were sufficient to convey historic and architectural significance. This includes the roof shape and materials, and a decorative cornice and portico. Part I was issued. In the rehabilitation, the concrete veneer was simply patched and retained as part of overall work.

In a second case, an owner submitted a Part 1 and Part 2 application with photographs of a 2 1/2 story, hip-roofed, frame and masonry building in a tree-lined district of similarly scaled residences. Photographs and a narrative explained that the building had been covered with a concrete veneered covering, and that the wood window sash and shutters had also been replaced with new aluminum "features" (see illus. 5). It was acknowledged in the application that these changes to the building did not contribute to its overall architectural appearance and historic integrity. Documentation also included several photographs of the interior showing raised paneling, parquet floors, tiled fireplaces, and intricate plaster cornice moldings and, in fact, the application emphasized the interior's significance.

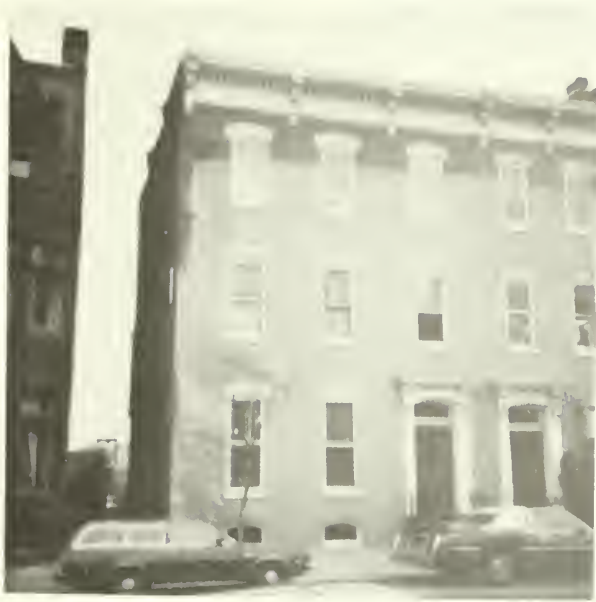
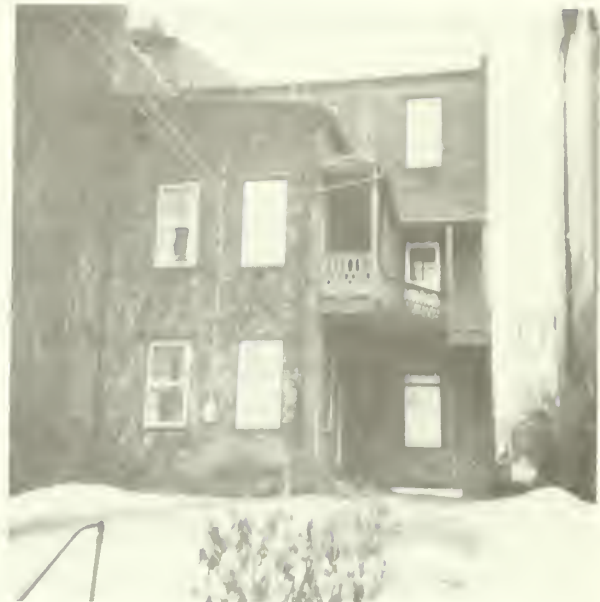
1, 2. The 3-story brick rowhouse, front and rear elevations, prior to conversion into a dress shop. Although many rear elevations are not particularly distinctive, this one featured a second story gallery and brick kitchen wing that were characteristic of the rear elevations of other residences in the district. Demolition of the wing and gallery preceded construction of a massive new addition that interrupted the former visual unity of the neighborhood.

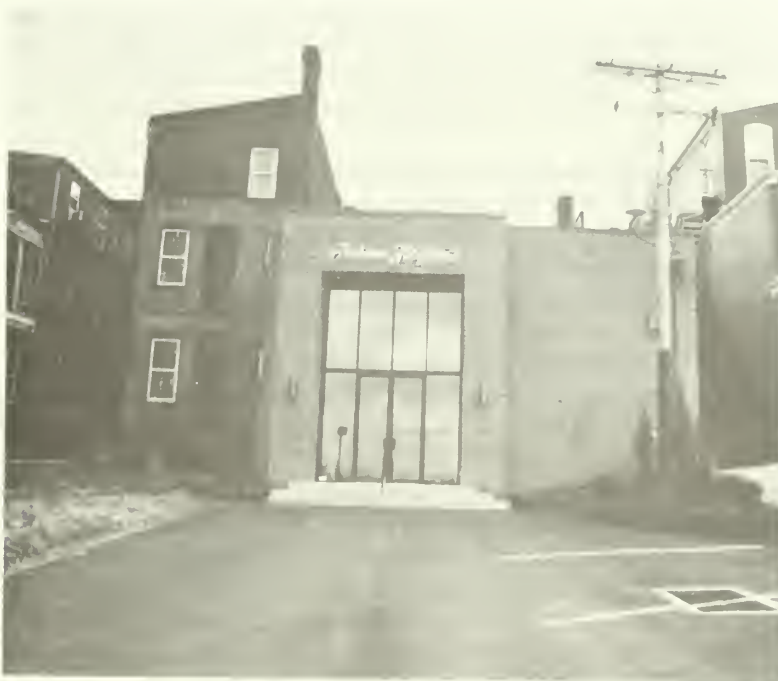
3. Completed work, rear elevation. The project was denied, largely based on demolition of the rear wing and porch and construction of a large addition that changed both the exterior form and interior plan.

Rehabilitation of the building essentially involved work to convert the residence into a dress shop. The owner felt that the existing interior space was inadequate for the retail operation, and, as a result demolished the historic rear ell and two-story porch preparatory to building a much larger addition in its place (see illus. 3).

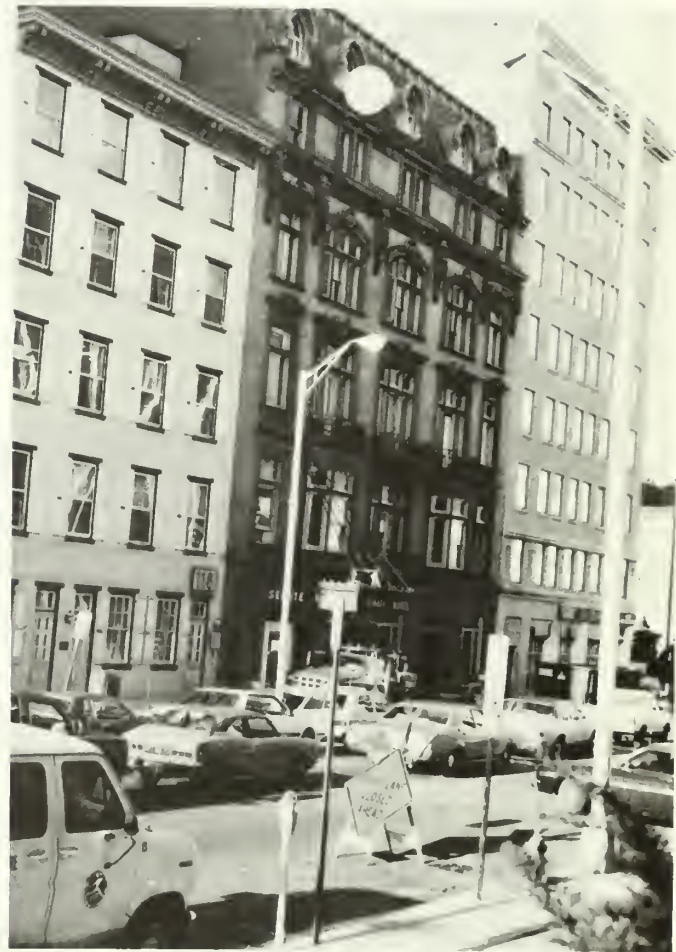
2. During rehabilitation into an office building the first floor is being reconstructed according to the original architectural drawings.

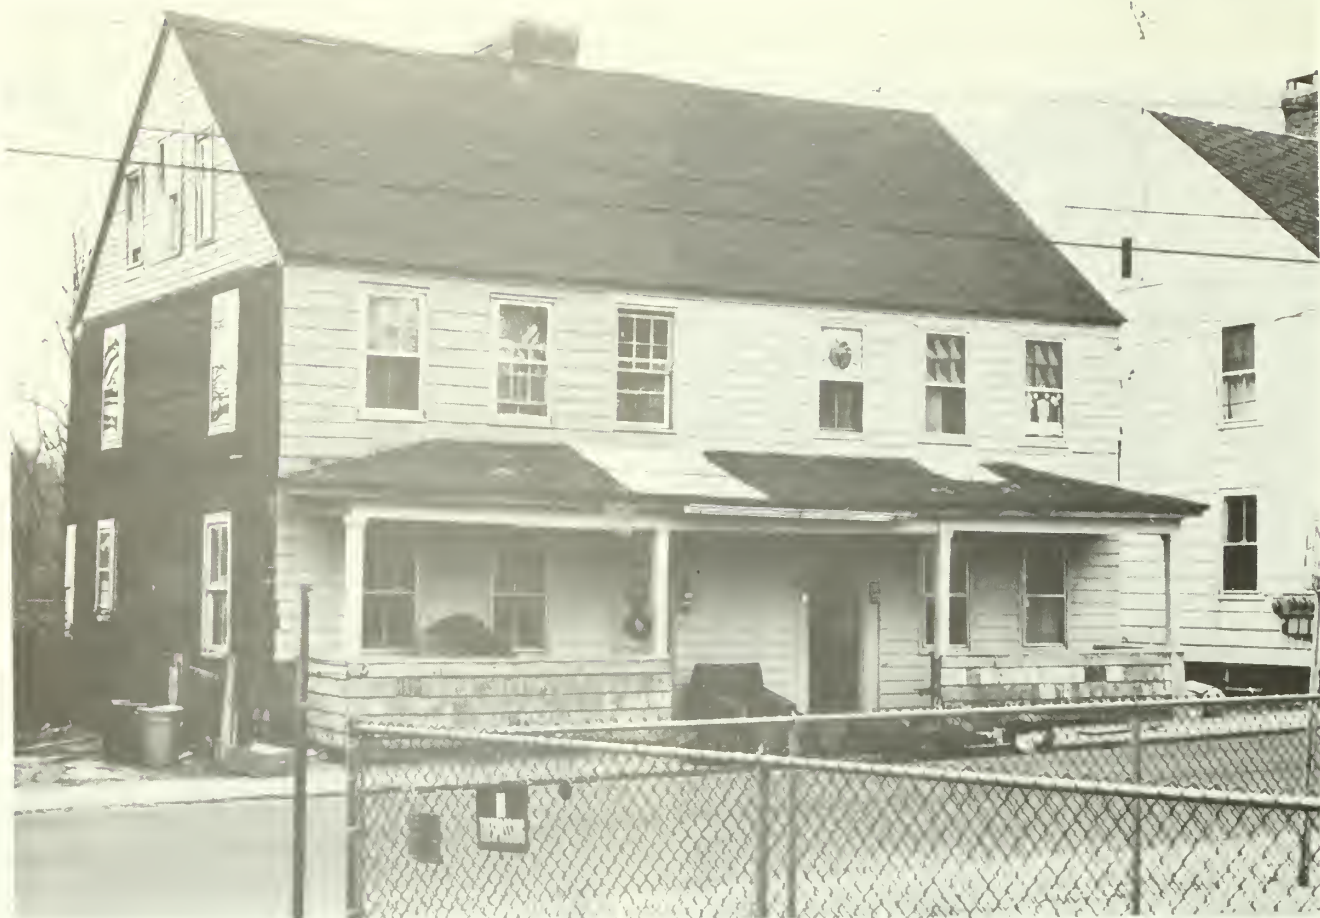
3-4. The two houses before rehabilitation. Because the porches were added after the historic district's period of significance, their removal was one option.

The owners appealed the regional decision, because they felt the rehabilitation met the Standards. At the appeal meeting the owners defended removal of the porches on the basis that the porches were poorly constructed of inappropriate materials which at the time of the rehabilitation were found to be too deteriorated to repair, and not of sufficient quality or workmanship to retain. Most importantly, however, research had revealed the fact that the porches in question were first depicted on the Sanborn insurance map of 1926, but did not yet appear on the map of 1914. Thus, the maps clearly showed that the porches had been built in the twentieth century, outside the period of significance of the district.

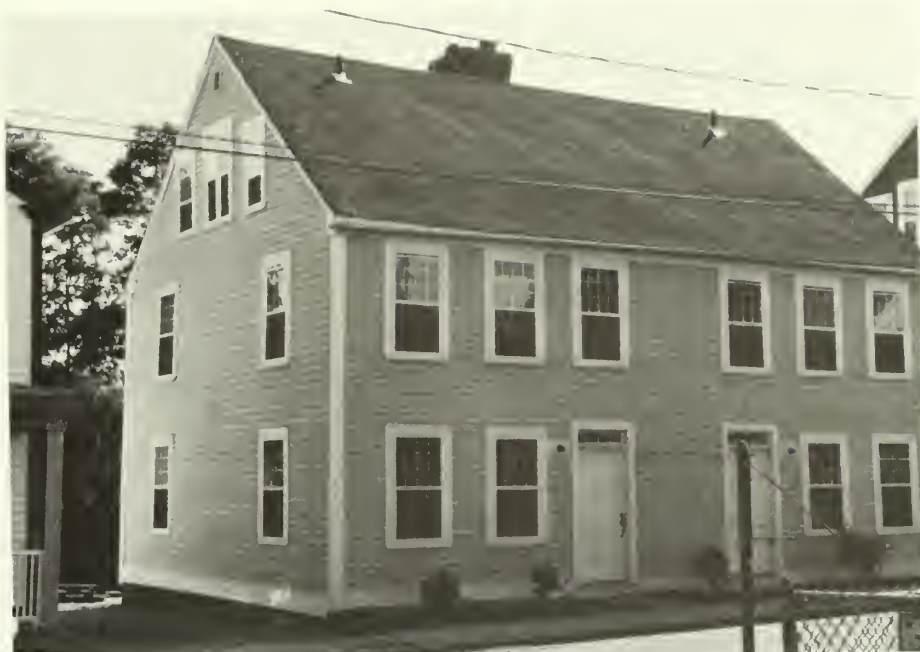
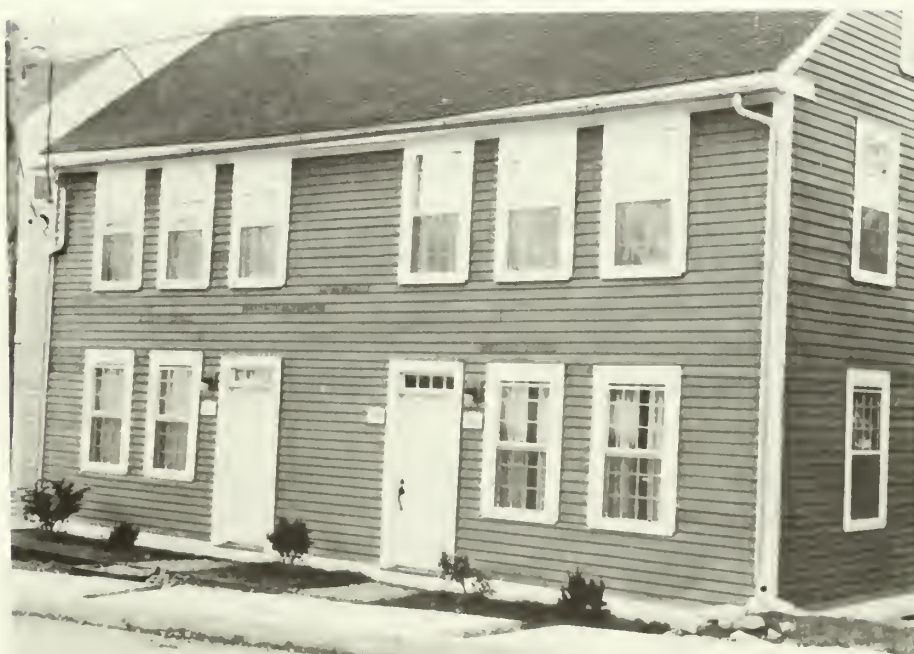
5-6. The two houses after rehabilitation, their porches removed to reveal the original early nineteenth-century character. (Twelve over twelve window replacement was based on remaining original sash still extant in several of the third floor windows.)

After reviewing all the facts of the case, the Chief Appeals Officer agreed with the owners that the rehabilitation met the Secretary of the Interior's "Standards," and overturned the denial issued by the regional office. In doing so, he stated that the primary significance of these properties lay in their exterior form and details, and that these character-defining features had been preserved and restored in the rehabilitation. Had the porches been in a better state of repair, their retention would also have been an option. He further explained his decision to the owner, saying:
